THE GROUND MOVEMENTS RELATED
TO BRACED EXCAVATION AND
THEIR INFLUENCE ON ADJACENT
BUILDINGS

Illinois Univ at Urbana-Champaign Dept of Civil Engineering

August 1976

Report No. DOT-TST 76T-23

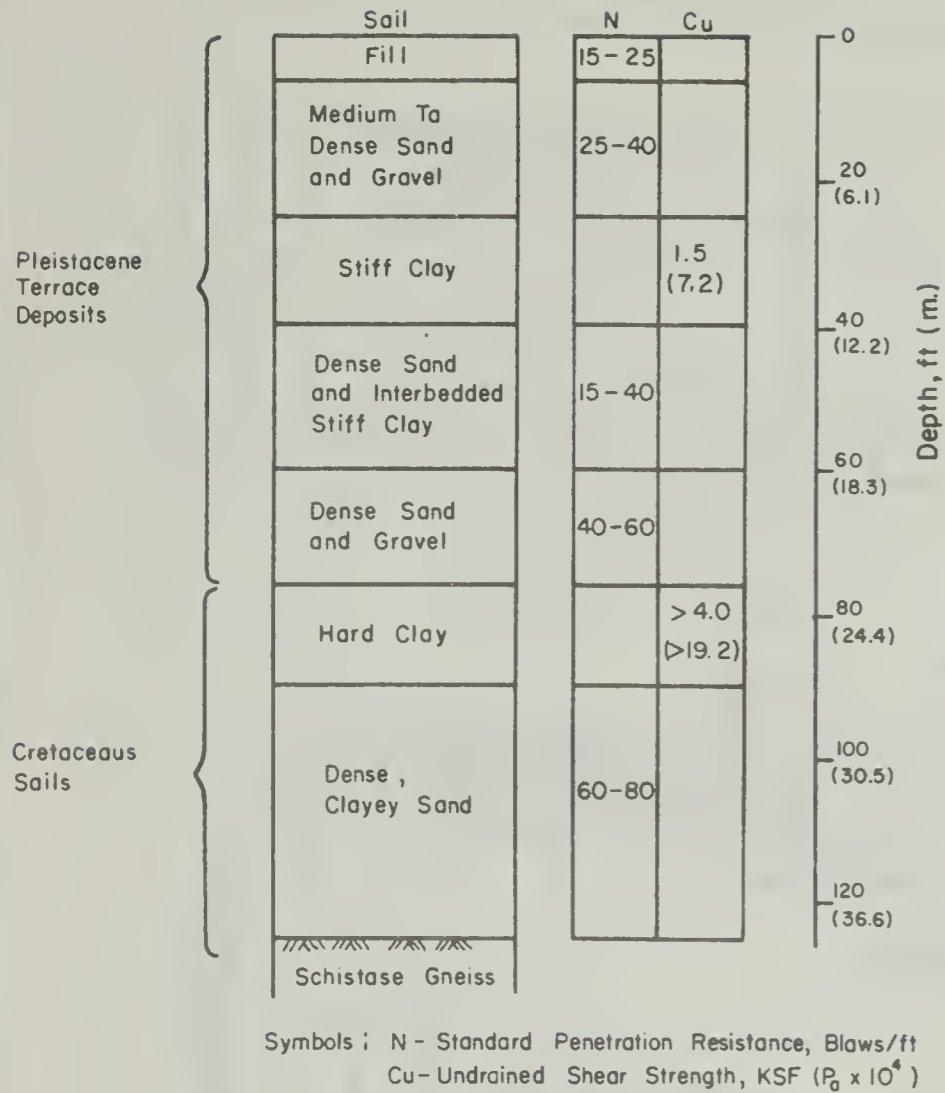
Fig. 2.1 Soil Profile for Braced Excavations in Washington, D. C.

The water table, before subway construction, was located at two levels. A perched water table above the stiff gray clay was found at a depth of approximately 15 ft (4.6 m) below the street surface. The water table in the lower

Pleistocene deposits was found at a depth of approximately 40 ft (12.2 m) below the street surface. During construction the granular soils of the Pleistocene and Cretaceous strata were dewatered below the subgrade of all braced cuts under study.

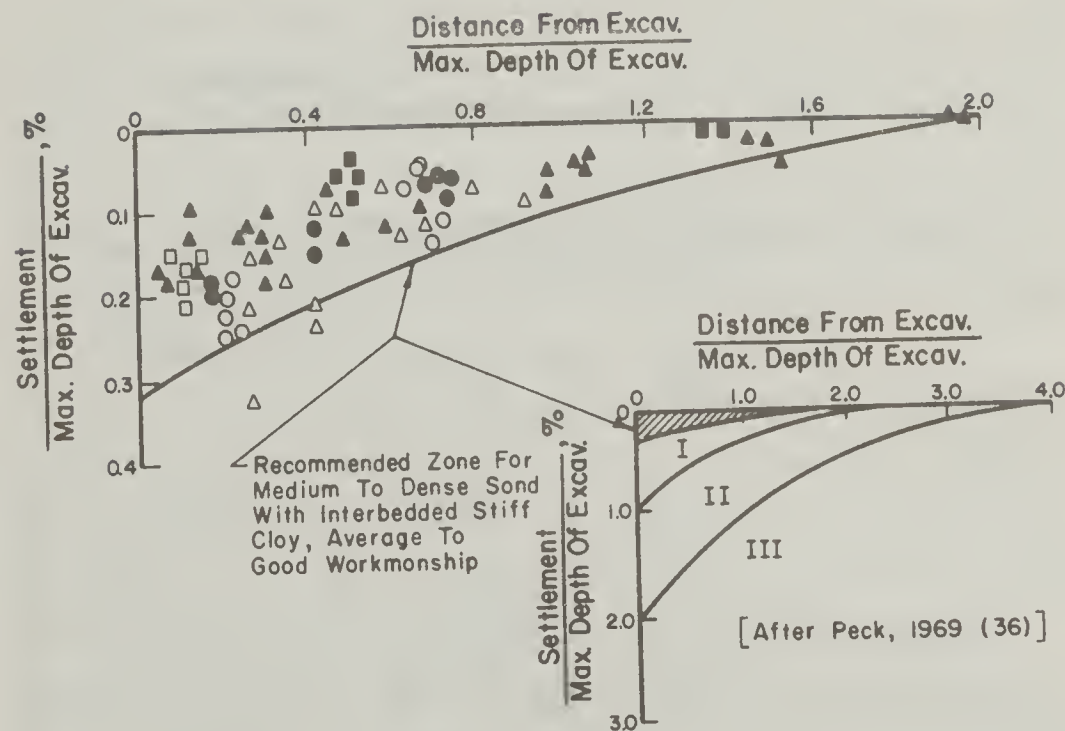
Cose	Symbol	Locotion	Max. Depth, ft	Support
1	●	7 th & G St., N.W.	60	Soldier Pile-Logging With Cross-Lot Struts For All Coses
2	○	9 th & G St., N.W.	60	
3	▲	11 th & G St., N.W.	55	
4	△	12 th & I St., N.W.	60	
5	■	7 th & G St., N.W.	80	
6	□	1 st & D St., S.E.	80

Fig. 2.2 Summary of Settlements Adjacent to Braced Cuts in Washington, D. C.

Previous research (34) has shown that ground movements generated by strut removal during subsurface construction can result in a 100 percent increase over the displacement caused by excavation to subgrade. Consequently, the total excavation history, including strut removal and backfilling, should be used as a baseline from which to judge the influence of soil movements on nearby structures. For this reason, the settlement data assembled in Fig. 2.2 represent both the initial and final stages of construction.

The construction procedure for each excavation was similar. The excavations were supported by cross-lot braces with vertical separations that averaged between 12 and 16 ft (3.7 and 4.9 m). The braced cuts were deepened approximately 20 to 25 ft (6.1 to 7.6 m) below the lowest, previously installed struts before installation of the next brace level. The excavation walls were

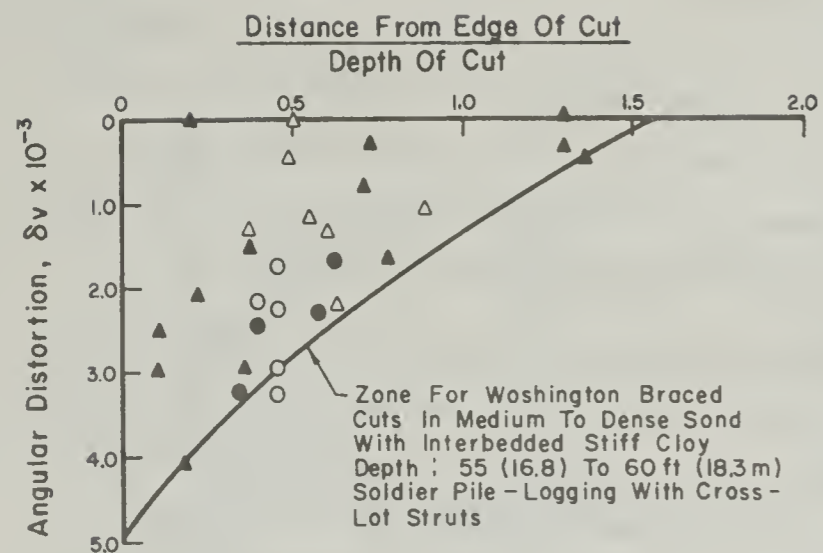
Case	Symbol	Max. Depth, ft (m)	Support
1	●	60 (18.3)	Soldier Pile-Logging With Cross-Lot Struts For All Cases
2	○	60 (18.3)	
3	▲	55 (16.8)	
4	△	60 (18.3)

Fig. 2.3 Angular Distortion for Braced Cuts in Washington, D. C.

Figure 2.3 shows the angular distortion associated with braced cuts in Washington, D. C. plotted as a function of the dimensionless distance from the edge of excavation. The angular distortion was estimated by dividing the differential settlement of two points along a line perpendicular to the edge of excavation by the distance separating them. The dimensionless distance associated with each value of angular distortion was estimated as the distance from the edge of excavation to a point midway between the two points from which the differential settlement was computed. The values of angular distortion shown in Fig. 2.3 were derived from the settlement measurements associated

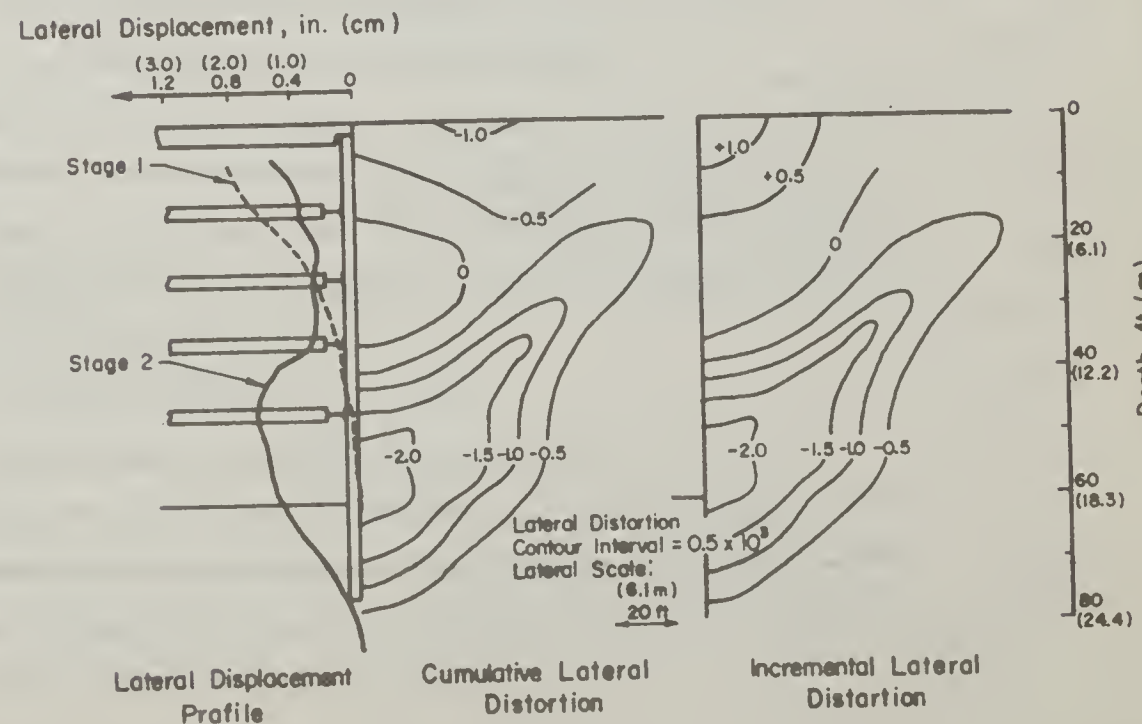
Fig. 2.5 Lateral Distortion Corresponding to Stage 2: Excavation to Subgrade

2. Excavation to subgrade after upper braces installed: As the upper braces were installed, the upper portion of the excavation wall was restrained from further lateral movement. In fact, preloading of the upper level struts resulted in a net decrease in the measured lateral movement near the top of the cut. The incremental distortion, plotted in Fig. 2.5, show that there was a recompression of the soil near the top of the excavation as referenced to the soil movement during stage 1 construction. In the deeper portions of the cut, the inward bulging of the excavation wall was associated with lateral tensile strains. These strains, shown in Fig. 2.5, emanate from a section of the wall

near the bottom of excavation in contours that loop upward from their point of origin toward the ground surface at an angle of roughly 45° from the vertical. Near the excavation wall, lateral ground strains were measured at a depth of 1.20 times the maximum depth of excavation.

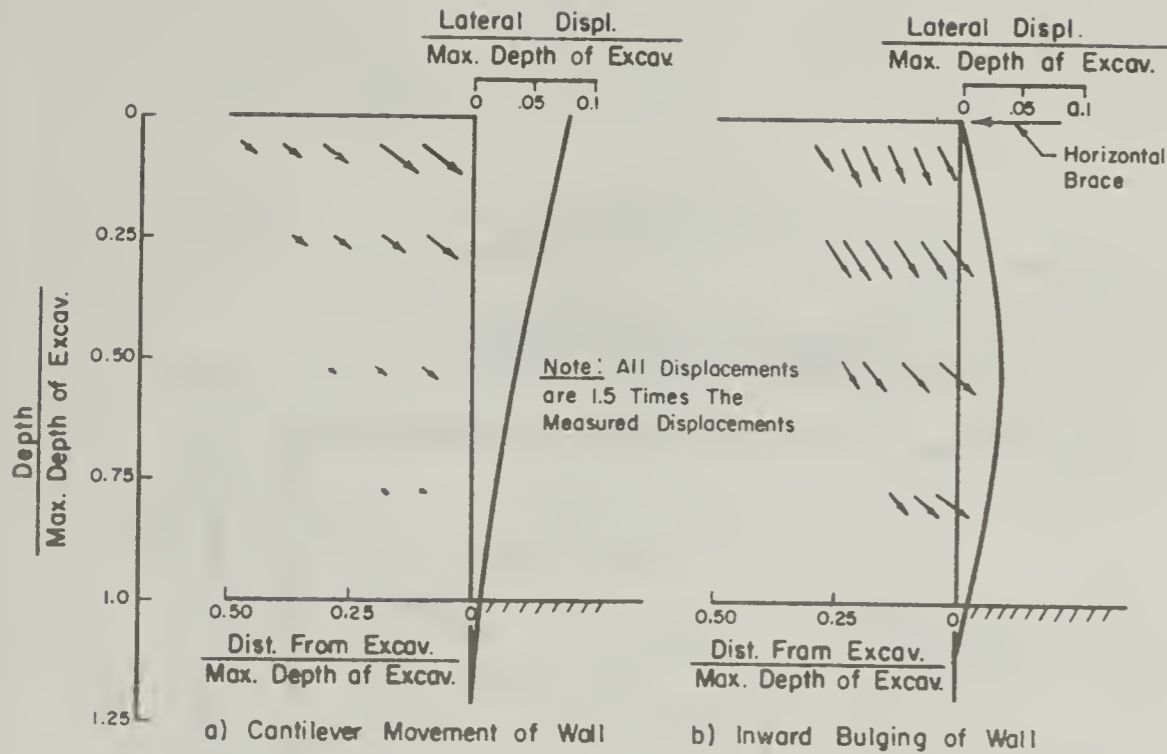
Fig. 2.7 Soil Movements Related to Model Tests with Sand

The wall deformations shown for the model tests are the results of a series of measurements taken at successively deeper excavation levels. For each stage of measured deformation, the patterns of soil movement remained unchanged and the magnitudes increased in proportion to the wall movements. Consequently, the final displacement vectors shown in Fig. 2.7 are representative of the movement patterns that developed for wall deformations as small as one-tenth those indicated.

The different types of wall deformation are reflected in the pattern of soil movement. Near the ground surface, the vector displacements for the cantilever movement of the wall show a ratio of lateral to vertical displacement ranging between 1.3 and 1.5. By way of contrast, the vector displacements for the inward bulging of the wall show a more complicated pattern of orientation. Horizontal restraint at the upper level of excavation has limited the development of lateral movement at this elevation. Correspondingly, the ratio of lateral to vertical displacement near the ground surface ranges between 0.5 to 0.7.

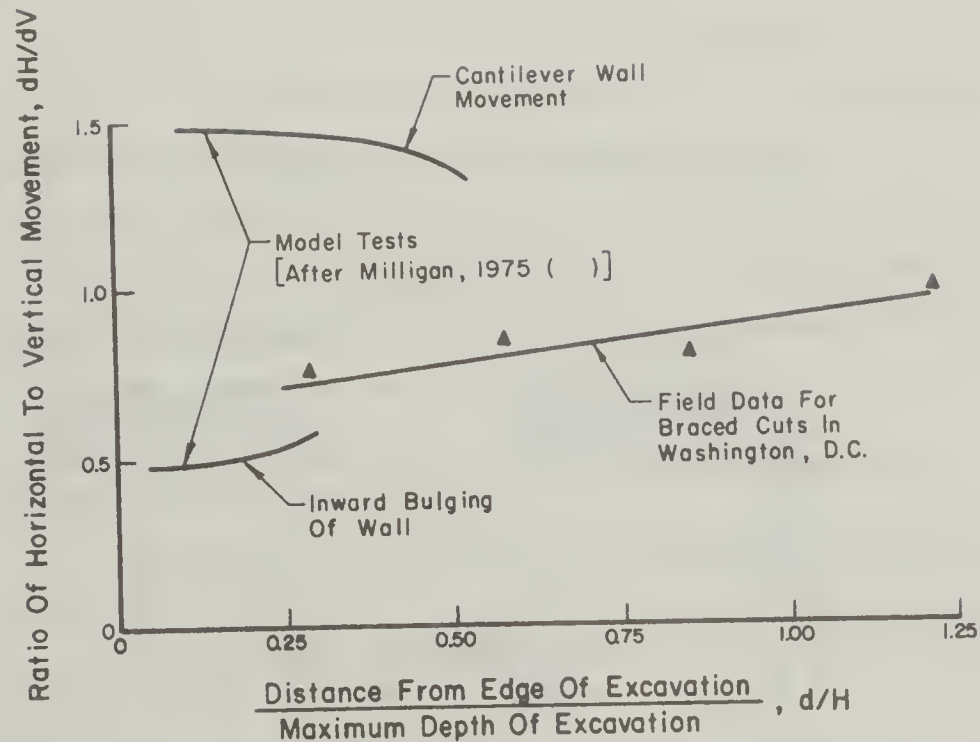
Fig. 2.8 Ratio of Horizontal to Vertical Ground Movements for Model Tests and Excavations in Washington, D. C.

Figure 2.8 summarizes the ratios of the horizontal to vertical surface movements that were measured for both the model tests and braced excavations in Washington, D. C. Ratios of horizontal to vertical displacement for the braced cuts were obtained from two different excavations. Settlement and inclinometer measurements, associated with the 60 ft (18.3 m) excavation described in the previous section, were combined to estimate ratios of surface movement within approximately 35 ft (10.7 m) of the edge of the cut. At greater distances from the excavation, precise optical leveling and tape extensometer readings near the column footings of a highrise apartment building were used. The apartment building is located within 40 ft (12.2 m) of a 60 ft (18.3 m) excavation. The ratios correspond to a time when the excavations had been deepened to subgrade and the bottom-level braces had been removed. Both excavations were characterized by a similar soil profile and construction procedure. The distances from the edge of excavation, within which the ratios of horizontal to vertical displacement were estimated, are expressed as a fraction of the maximum excavation depth.

The results of the model tests serve to bracket a range of surface displacement patterns that can be anticipated within the zone of plastic soil behavior. Within this framework the field data appear to represent a reasonable ratio of lateral to vertical displacement. The field data indicate that the ratio of horizontal to vertical movement increases with distance from the edge of excavation, ranging from the value of 0.7 at a distance of 0.25 the maximum excavation depth to nearly 1.0 at distances exceeding the maximum excavation depth.

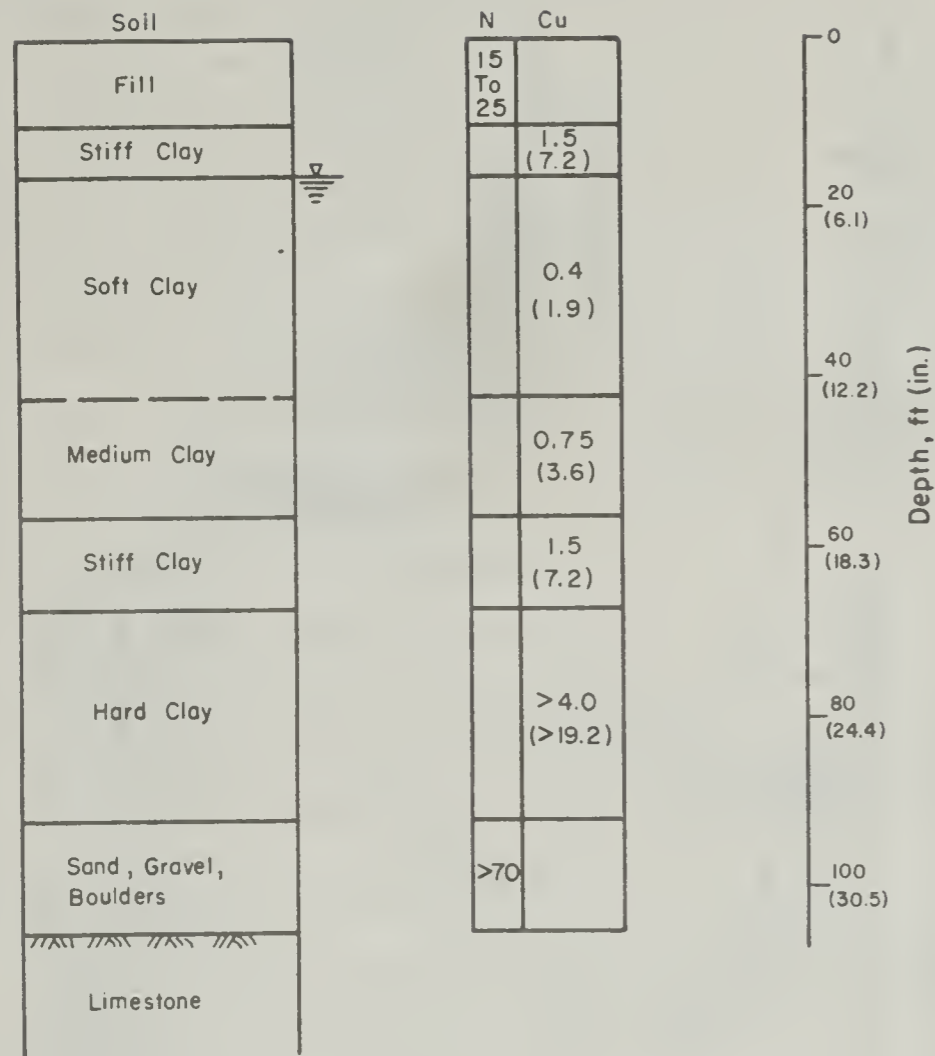
Symbols: N - Standard Penetration Resistance, Blows/ft
Cu - Undrained Shear Strength, KSF ($P_0 \times 10^4$)

Fig. 2.9 Soil Profile for Braced Excavations in Chicago

Figure 2.9 shows a typical soil profile for downtown Chicago. Representative values of undrained shear strength are listed for the clays and typical standard penetration rates are listed for the granular soils. A notable stratum of soft clay occurs at a depth of approximately 15 ft (4.6 m) below the street surface. The soft clay grades into clay of medium consistency at a depth of approximately 40 ft (12.2 m), however the transition zone

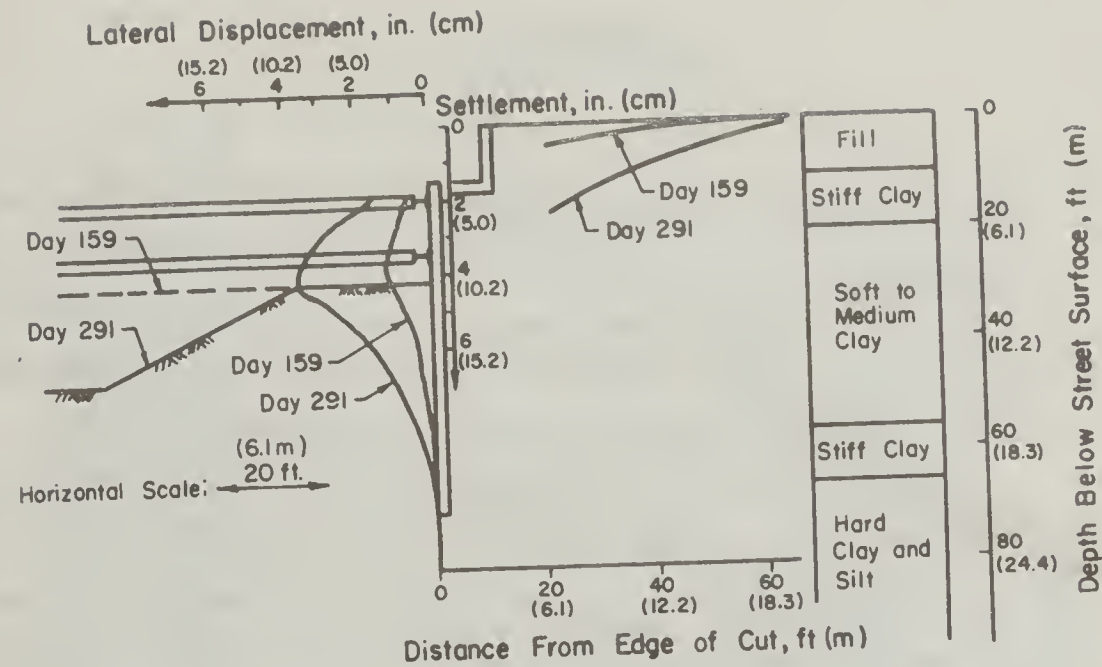
Fig. 2.11 Soil Displacements for Case 1

Figures 2.11 and 2.12 show the lateral wall displacements associated with case 1 and case 1a, respectively. The wall of this excavation was composed of 14BP73 soldier piles on 7-ft (2.1-m) centers with wood lagging installed between adjacent soldier piles. The wall was supported in its upper levels by two tiers of cross-lot and diagonal struts that were preloaded to 50 percent of the design brace load. The central portion of the excavation was deepened to a subgrade level of 44 ft (13.4 m) below the surrounding street surface. Large berms were left in place against the north and east walls of the cut as shown in Fig. 2.11. The berms were approximately 25 ft (7.6 m) wide at the top and were sloped at an angle of roughly 30° from the horizontal. The lateral wall displacements and surface settlements before and after excavation of the central area of the cut are indicated in the figure. By way of contrast, Fig. 2.12 shows the lateral displacements for the south wall of the excavation where the berms were removed and replaced with raker supports. A comparison of the two figures indicates that the transfer of lateral restraint from berms to the raker system was relatively inefficient. Installation of the bottom rakers required that the berms be diminished to a size appropriate for insertion of the raker support. Excavation of this nature decreases the lateral restraint at the excavation wall as well as reduces the dead weight of soil acting to limit bottom heave. The reduction of berm support in combination with deformation and adjustment of the rakers contributed to the prominent inward bulging shown in Fig. 2.12. The increased displacement emphasizes the need for careful excavation of the soft clay in combination with prompt installation of stiff bracing.

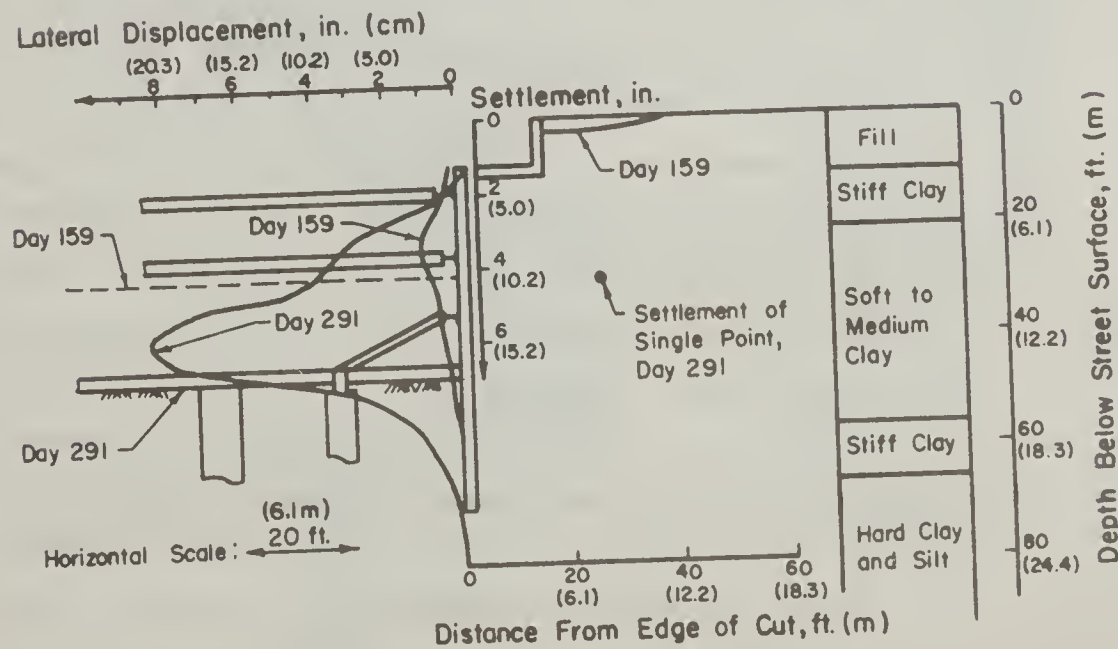
Fig. 2.12 Soil Displacements for Case 1a

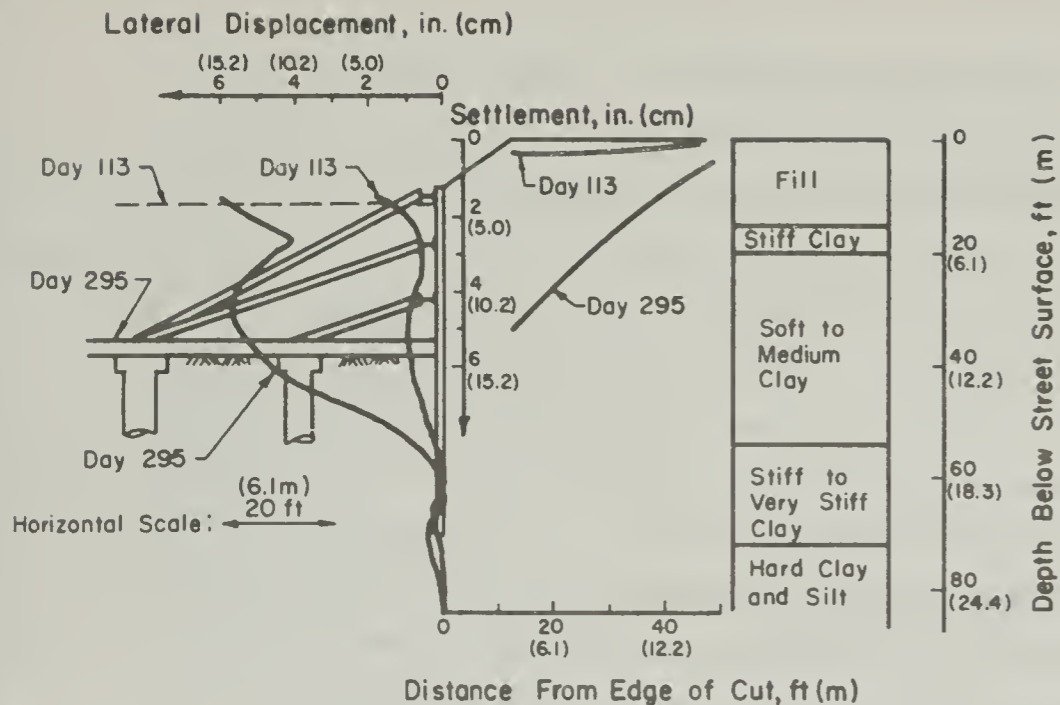
Fig. 2.13 Soil Displacements for Case 9

Figure 2.13 shows the lateral wall displacements associated with case 9. The wall of this excavation was composed of MZ 38 sheet piles that were supported by three levels of rakers. The rakers were not preloaded during installation. Lateral movement and settlement profiles are shown for excavation levels corresponding to a depth of 13 and 37 ft (4 and 11.3 m). Most of the lateral displacement developed in the strata of soft to medium clay in a manner similar to the ground deformations shown in Fig. 2.12. As in Fig. 2.11, the volume of lateral wall movement is approximately equal to the volume of settlement behind the sheeting line. Substantial displacements occurred as both the excavation was deepened to subgrade and the temporary berms were removed during raker installation. Large increases in lateral deformations, ranging from 4 to 5 in. (10.2 to 12.7 cm), occurred at all raker levels as the excavation was extended into the soft and medium clays.

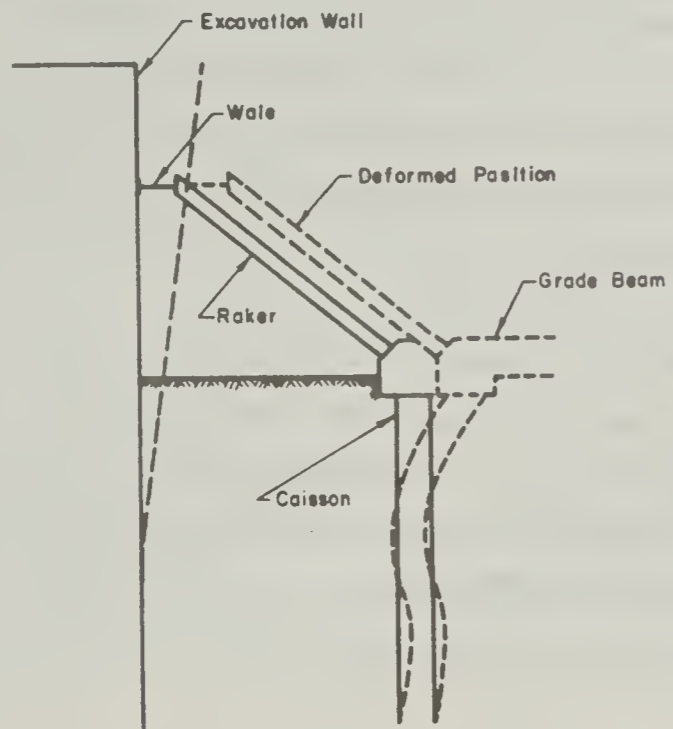
Fig. 2.14 Wall Movement Associated with Lateral Displacement of Caissons

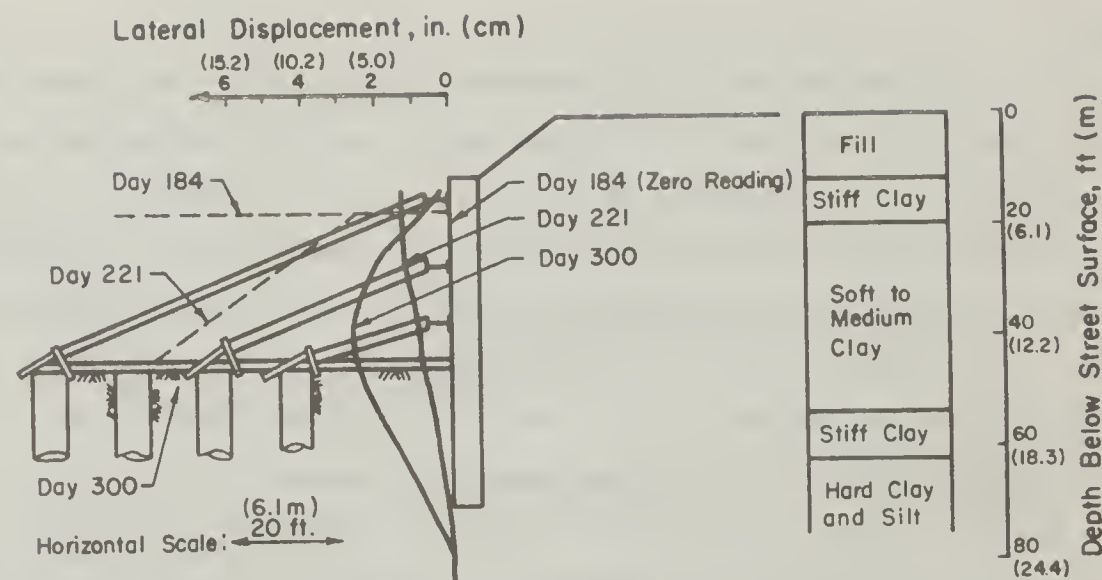
Fig. 2.15 Soil Displacements for Case 7

Figure 2.15 shows the lateral wall displacements for case 7. The large ground movements, which occurred during caisson construction at this site have not been indicated in order to concentrate on the specific displacements that developed during opencutting. Hence, the lateral displacements have been referenced to a time after the completion of caisson construction and before excavation in the soft and medium clays. The excavation was supported by a 30-in. (76.2-cm)-thick, concrete slurry wall, restrained at three levels by rakers. The upper two raker levels were preloaded to 50 percent of the design load. The installation of the first level rakers occurred while substantial berms were in place. The installation of all raker levels corresponded closely with construction of the basement slabs in the areas of raker abutment so that a sound foundation bearing was provided. The wall displacements extend to a deeper level than those shown on Figs.

2.13 and 2.14, and reflect the nature of the concrete wall whose stiff section tended to transmit movement into the underlying soils. The volume of lost ground is approximately one-half that for the sheet pile excavation shown in Fig. 2.13 that used a similar scheme of raker support.

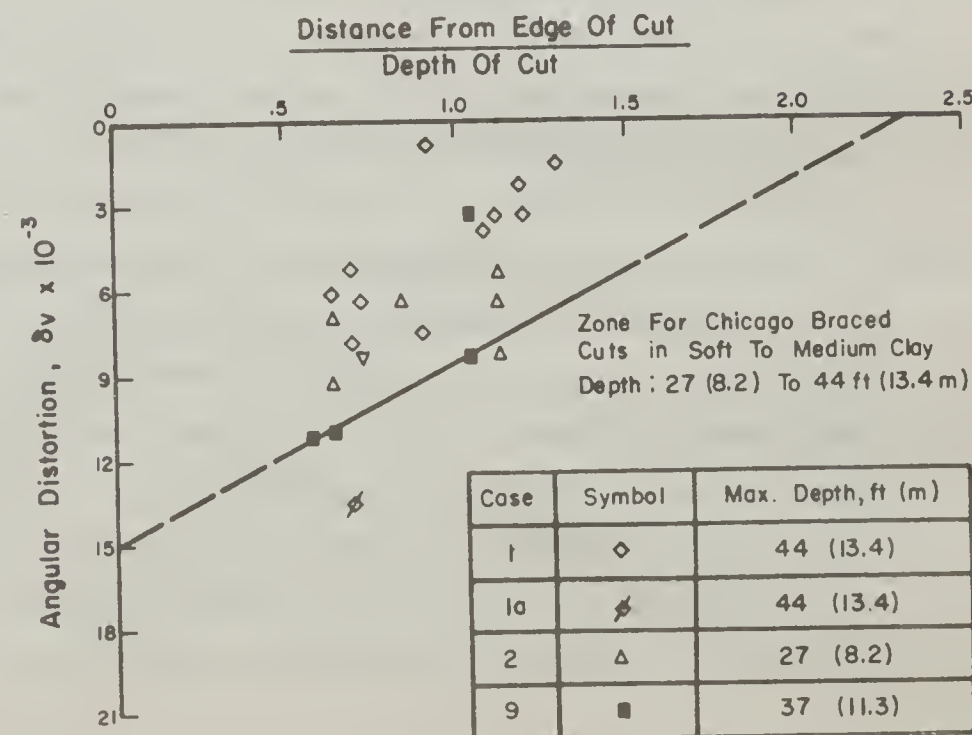
Fig. 2.16 Angular Distortion for Braced Cuts in Chicago

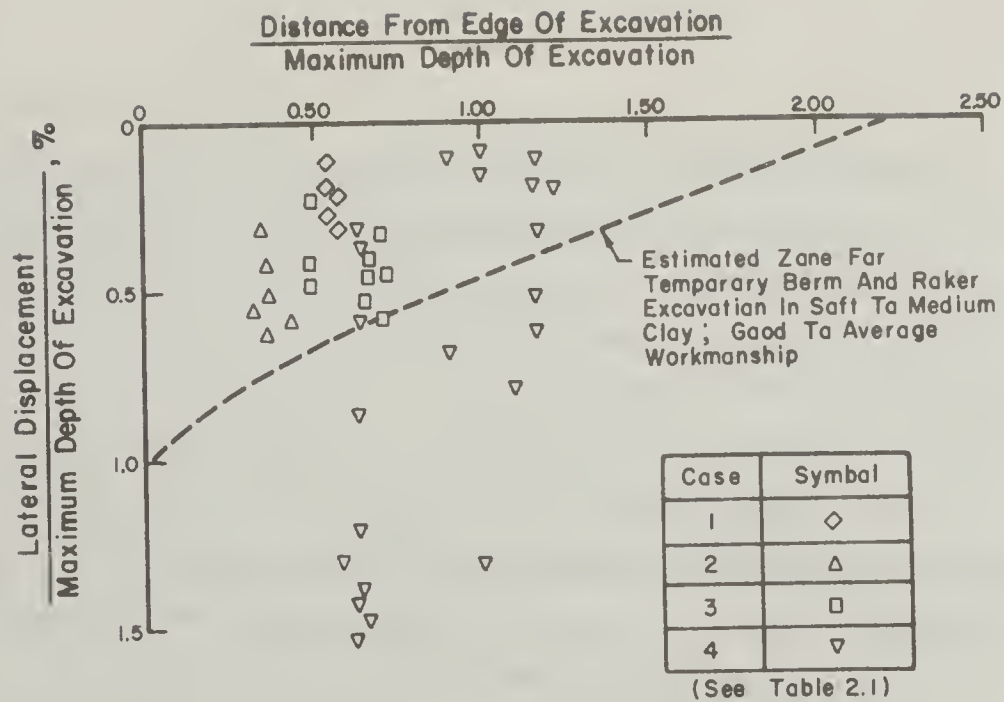
Fig. 2.17 Summary of Lateral Displacements Adjacent to Braced Cuts in Chicago

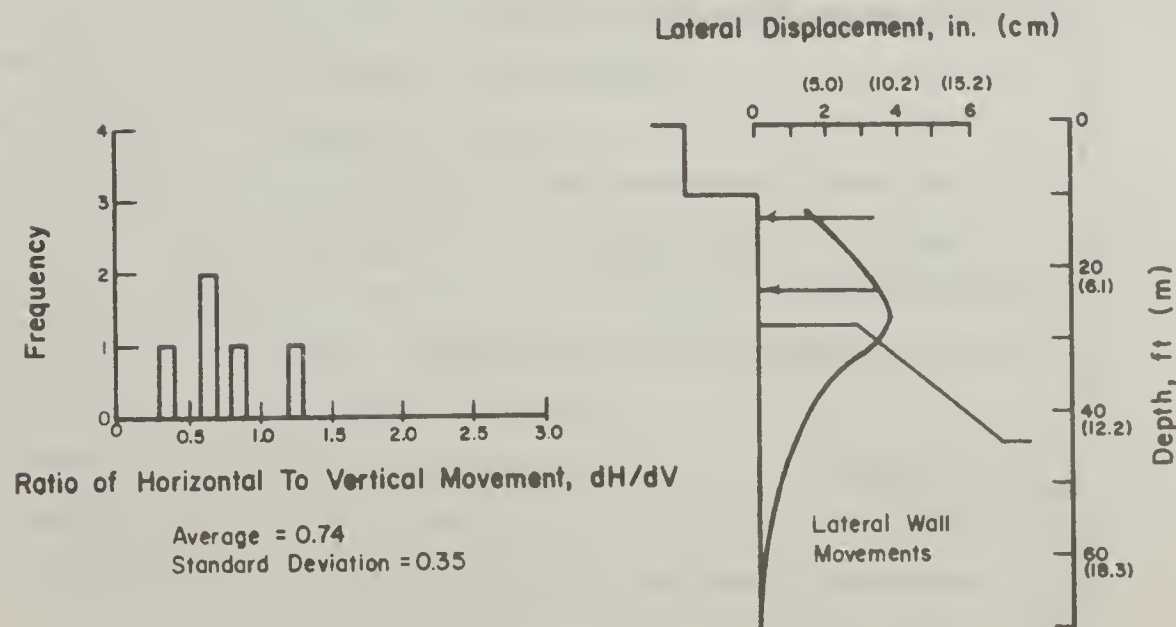
Fig. 2.18 Ratios of Horizontal to Vertical Ground Movement for Case 1

The average ratios of horizontal to vertical displacement for the five excavations, referenced in Figs. 2.18 through 2.22, are plotted as a function of the coefficient of deformation in Fig. 2.23. For values of the coefficient greater than 4 and less than 1, the ratio of lateral to vertical displacement

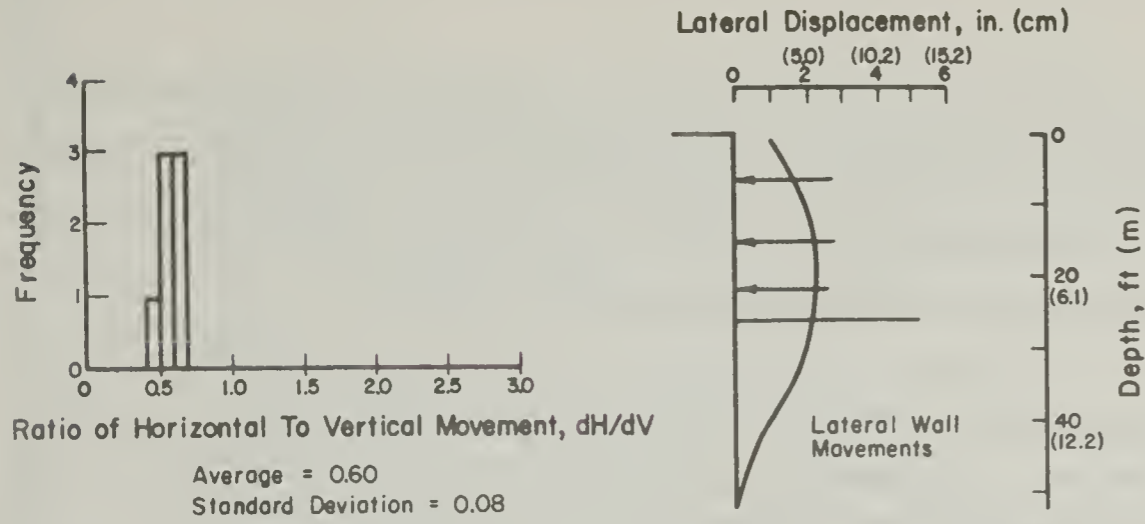
Fig. 2.19 Ratios of Horizontal to Vertical Ground Movement for Case 2

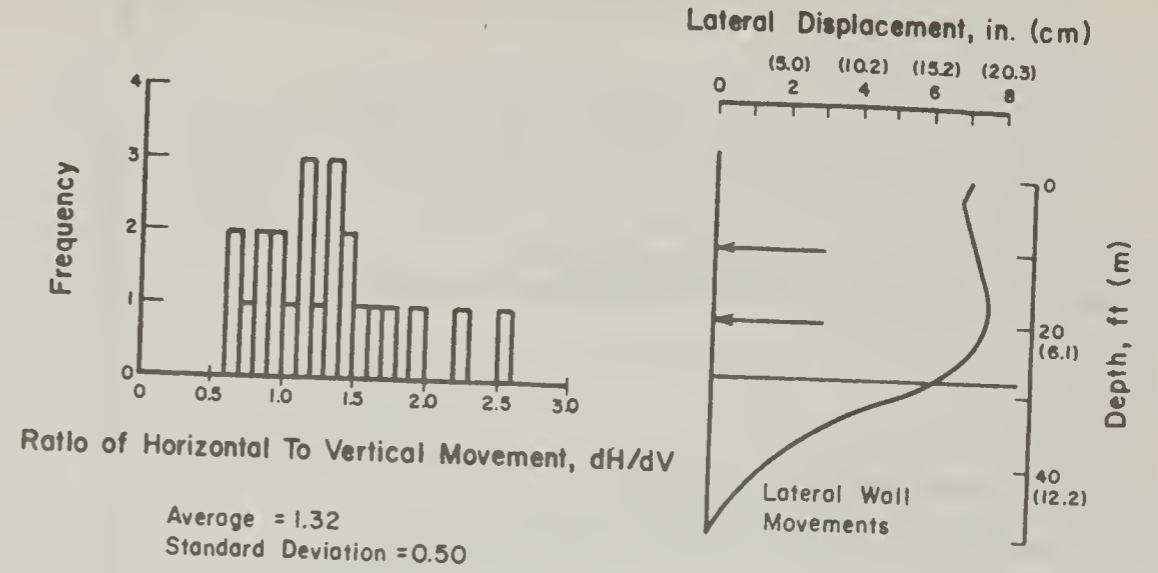
Fig. 2.21 Ratios of Horizontal to Vertical Ground Movement for Case 4

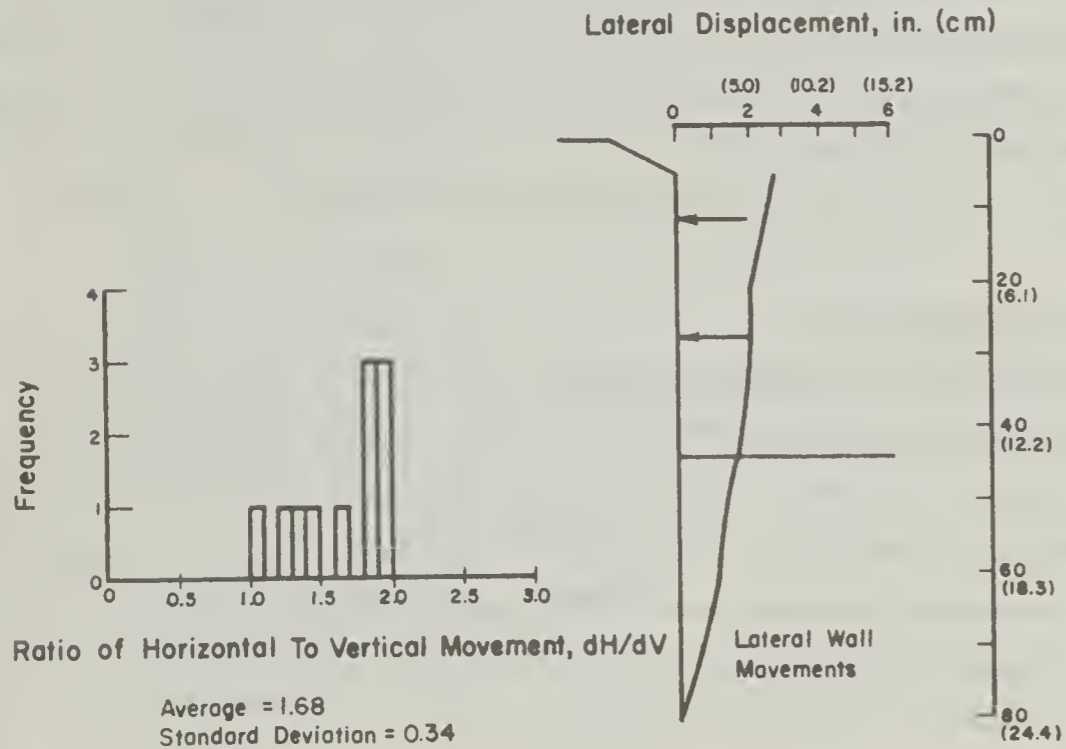
Fig. 2.20 Ratios of Horizontal to Vertical Ground Movement for Case 3

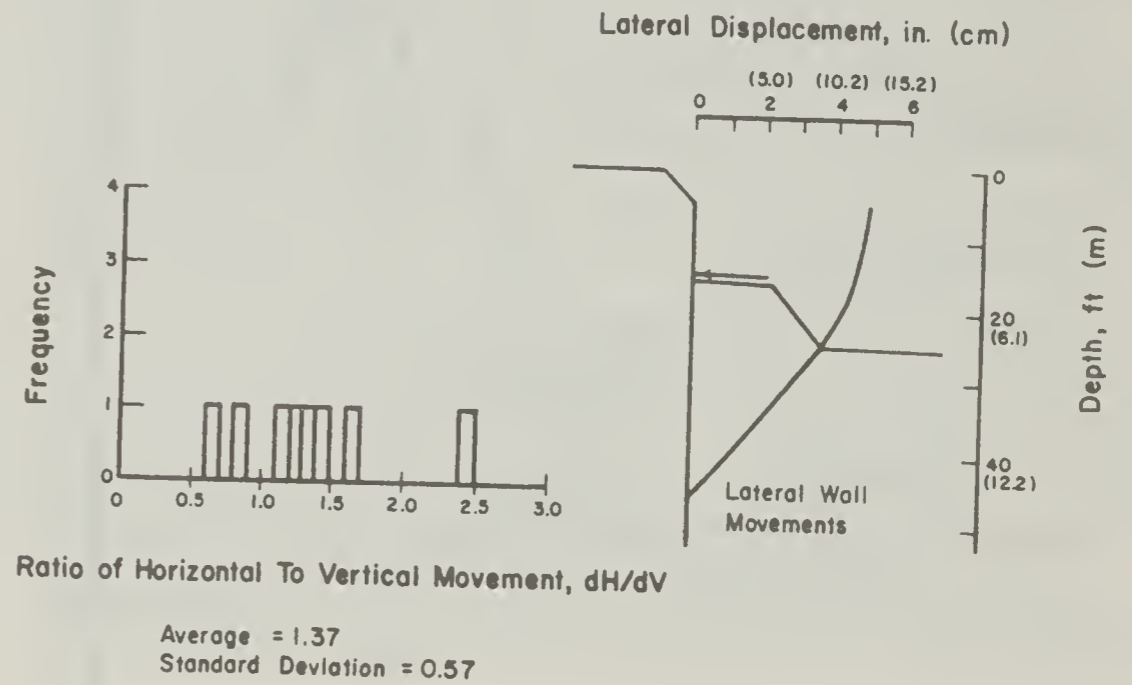
Fig. 2.22 Ratios of Horizontal to Vertical Ground Movement for Case 10

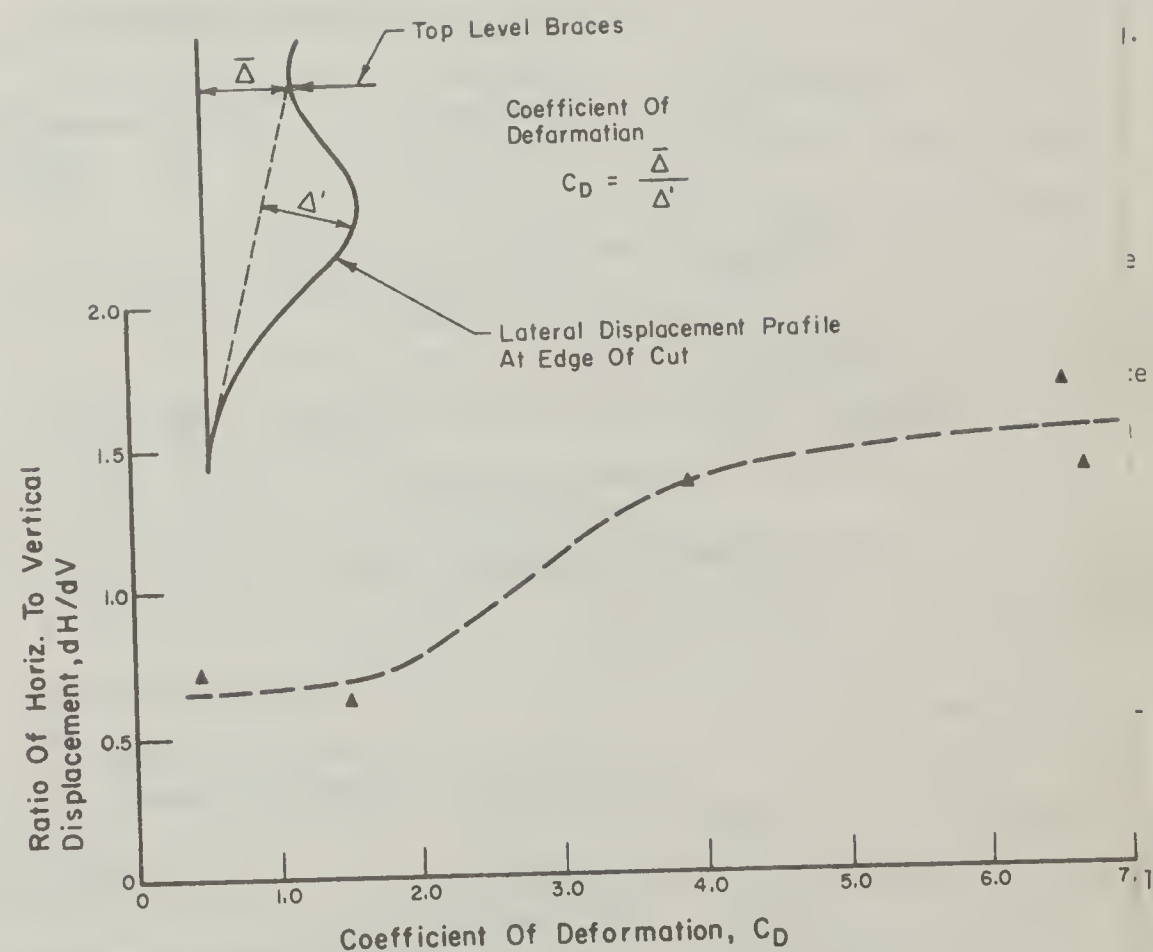
Fig. 2.23 Relationship Between the Ratio of Horizontal to Vertical Ground Movement and the Coefficient of Deformation

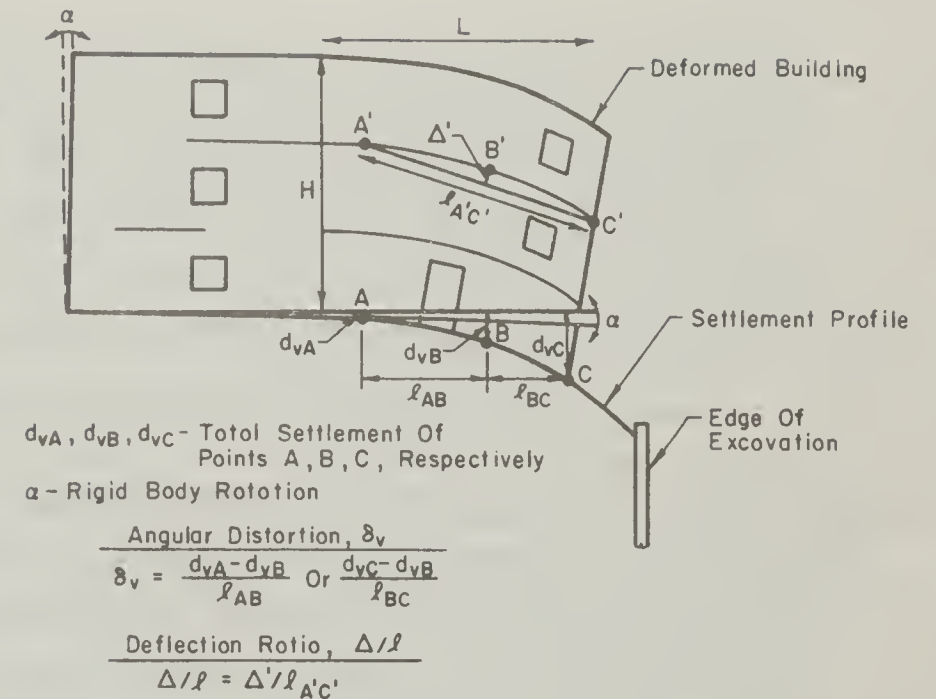
Fig. 3.1 Building Deformation Caused by Settlement in Response to Opencutting

In the figure, rigid body tilt is indicated by the angle, α . Often, rigid body tilt is extremely difficult to estimate on the basis of settlement, especially settlement related to opencutting. In addition, the settlement profile associated with opencutting develops in stages as the excavation is carried to subgrade. Consequently, the building is subjected to a settlement wave that causes bending and shear distortion in the structure even though the final slope of the settlement profile may be constant. In most cases, the building dimension perpendicular to the edge of excavation is relatively large with respect to the length of the settlement profile. For the general case, therefore, the evaluation of angular distortion directly from differential settlement is a reasonable way to estimate the deformed shape of the building. Rigid body tilt, however, must be considered in certain applications, especially when judging the influence of settlement on stiff, narrow structures. In these cases, rigid rotations should be evaluated

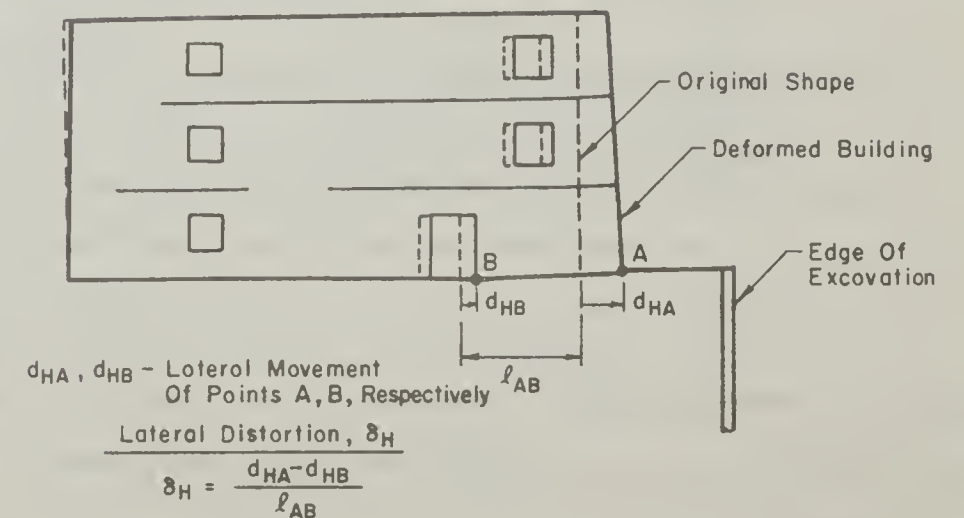
Fig. 3.2 Building Deformation Caused by Lateral Displacement in Response to Opencutting

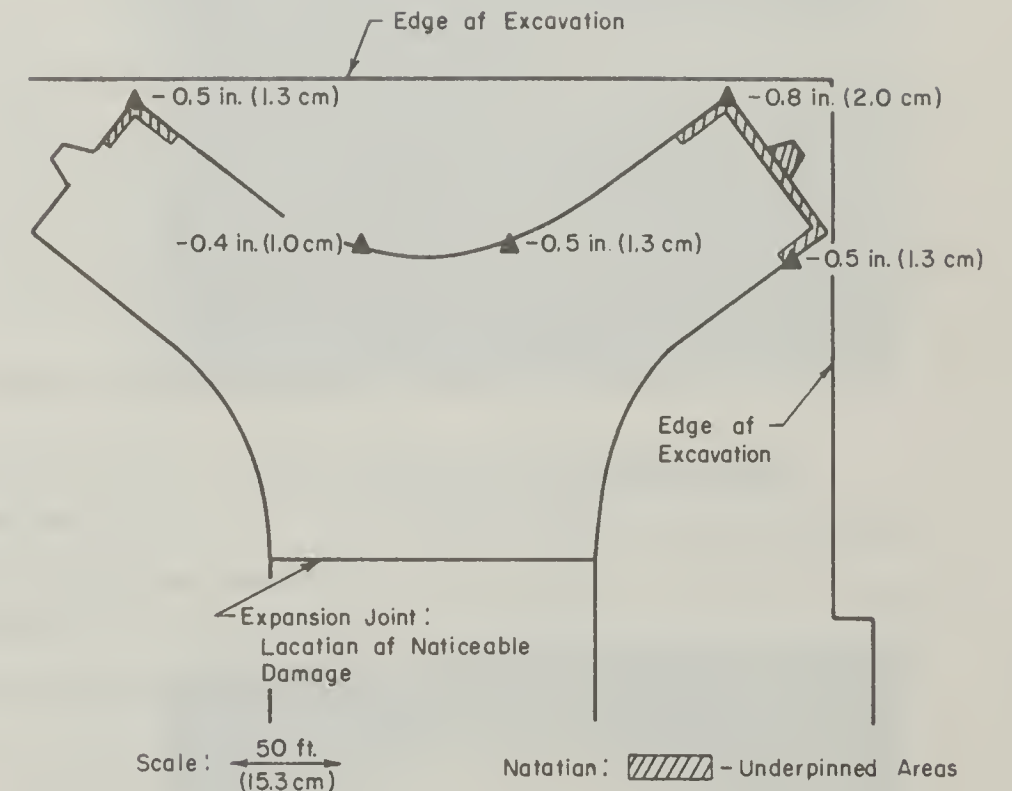
Fig. 3.5 Plan View of a 10-Story, Concrete Frame Structure with Settlement Caused by Adjacent Excavations

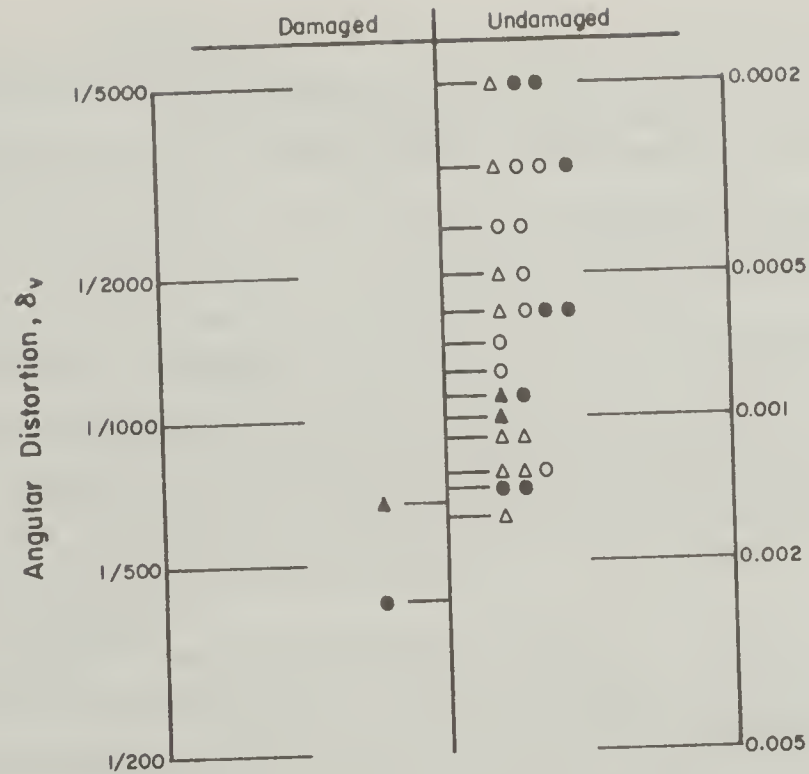
Symbol	Age	Description
●	50 To 80 Yrs.	2-4 Story Brick Bearing - Wall Structures With Timber Beams; Rubble Foundations
▲	35 Yrs.	13 Story Steel Frame With Concrete Floors, Infilled Plaster Partition Walls; Spread Footing Foundation
○	≈20 Yrs.	6 Story Steel Frame With In-Filled Hollow Block and Plaster Walls; Spread Footing Foundation
△	45 Yrs.	10 Story Steel Frame With Concrete Floors and In-Filled Brick Walls; Spread Footing Foundation 2 Basement Levels

Only two instances of damage are indicated. In one case, a brick-bearing wall settled as the result of excavating an underpinning pit beneath it. The angular distortion, measured relative to the opposite bearing wall of the structure, was 2.4×10^{-3} (1/417). Several cracks and a sticking door were reported. In the other case, angular distortion of 1.5×10^{-3} (1/667) was measured in response to the settlement of an H-column during underpinning.

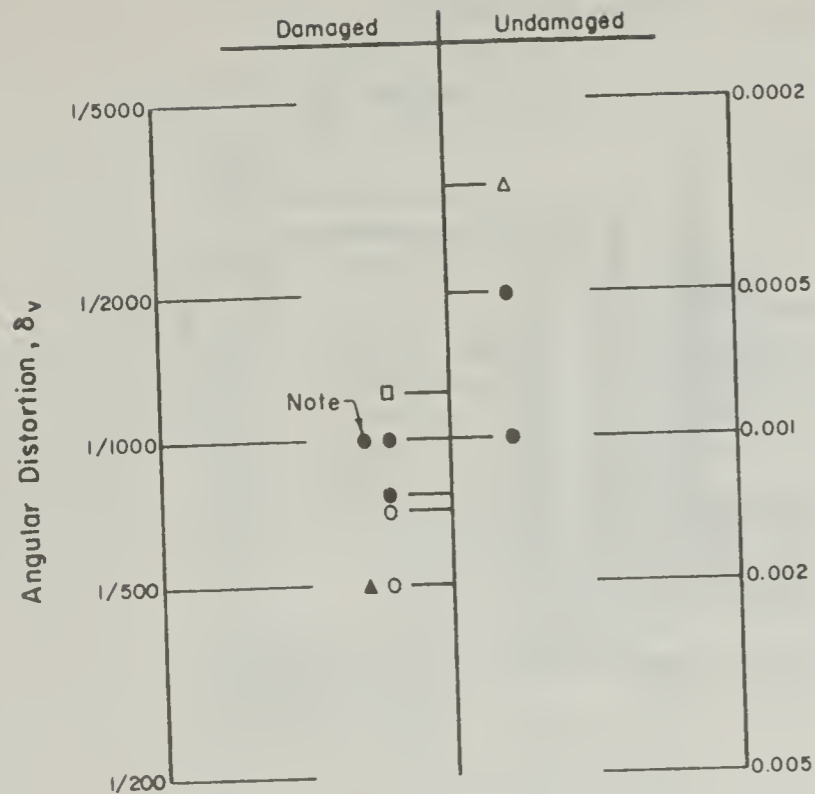
Symbol	Age	Description
●	50 To 80 Yrs.	2-4 Story Brick Bearing-Wall Structures With Timber Beams Mostly Rubble Foundations
▲	≈50 Yrs.	6 Story Steel Frame With Brick In-Filled Walls; Spread Footing Foundation
○	>50 Yrs.	9-10 Story Steel Frame With Brick Curtain Walls; Spread Footing Foundation
□	5 Yrs.	10 Story Reinforced Concrete Frame; 4.5' ft. (1.4 m) Thick Reinforced Concrete Mat Foundation; 2 Basement Levels
△	10 Yrs.	9 Story Reinforced Concrete Frame; Flat Slab Construction; Spread Footing Foundation

Fig. 3.7 Field Evidence of Architectural Damage Related to Angular Distortion for Structures Adjacent to Braced Excavations

For buildings adjacent to deep opencutting, evidence concerning architectural damage and angular distortion is summarized in Fig. 3.7. The maximum, angular distortions pertaining to 9 brick-bearing wall and 5 frame structures have been plotted. One of the data points, pertaining to brick-bearing wall structures, represents a row of 5 commercial buildings that were
